# LANDLOK<sup>®</sup> REPORT

An Erosion Control Case Study From Synthetic Industries

## Landlok<sup>®</sup> TRM 1061B Proves Ideal For Water Reservoir Slope Stabilization

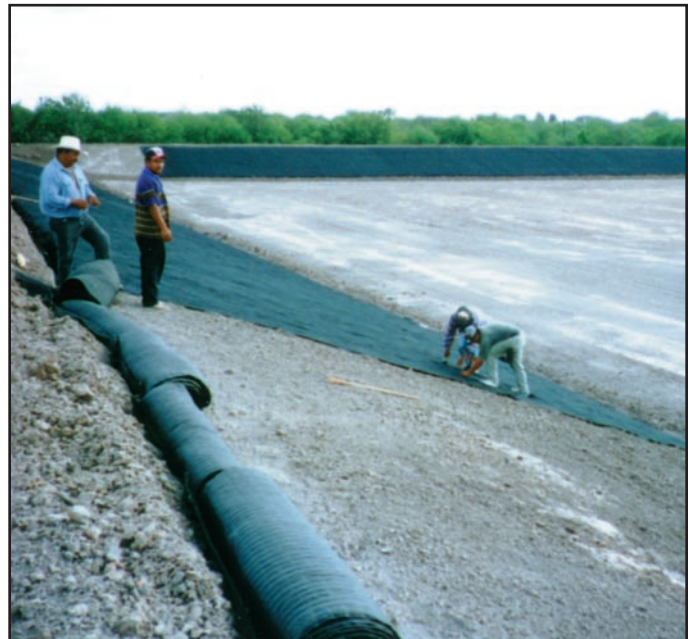
*Installation of Landlok<sup>®</sup> TRM 1061B*

Landlok TRM 1061B, manufactured by Synthetic Industries, is a turf reinforcement matting backed with a lightweight, nonwoven geotextile fabric that is an ideal alternative to hard armor protection. It is specially designed for turf reinforcement, providing protection from minor wave action and minimizing the potential movement of soil particles during rapid draw down periods.

The Contractor began construction in May 1996. After preparation of the subgrade, the TRM was installed on the slopes with the necessary pinned and trenched tucks at top and bottom. The mat was also pinned in accordance with the recommended schedule for 3:1 slopes. After installation, the mats were seeded with a localized seed mix and soil filled. The contractor installed a temporary watering system for the necessary water required for germination.

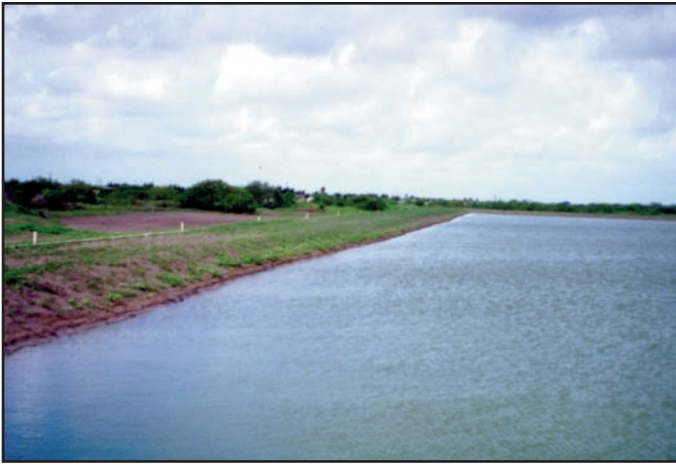
*Vegetation Beginning to Flourish.*

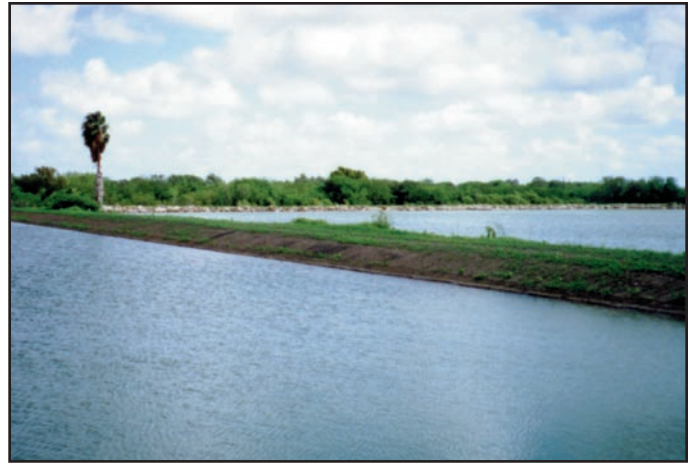
*Vegetation after three months.*

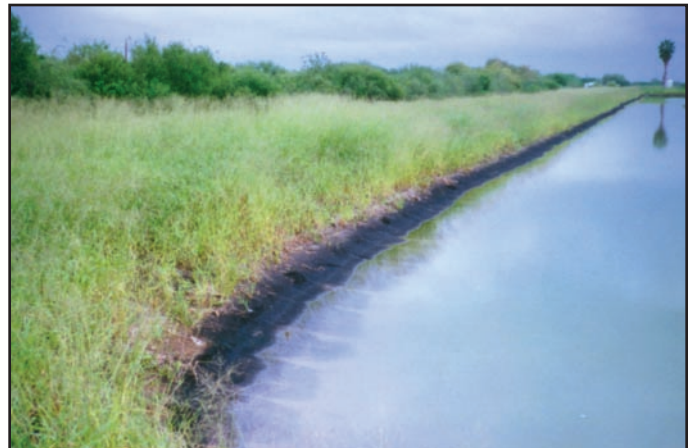
*Slope fully vegetated after one year.*

The use of Landlok TRM 1061B in lieu of traditional hard armor protection proved quite cost-effective. Bid prices for the TRM installed were approximately one-half of the estimated cost of using rock rip-rap which allowed the local water district to build more reservoir storage capacity for the same dollar. Nearly two years later, the project site was inspected by the design engineer. There were no signs of erosion on any of the embankments and healthy vegetation existed through the matting above the water line. It was also noted that maintenance, should any be required, would be easy to perform as compared to hard armor rock and fabric.
